Applying the SAFEGROUNDS Key Principles in the real world: A case study at Hunterston A - *the VLLW Disposal Area*

SAFEGROUNDS/SD:SPUR Conference on
“Managing Contaminated Land and Decommissioning Wastes on
Nuclear and Defence Sites”, Manchester, 3-4 June 2009

Hunterston A Site, North Ayrshire

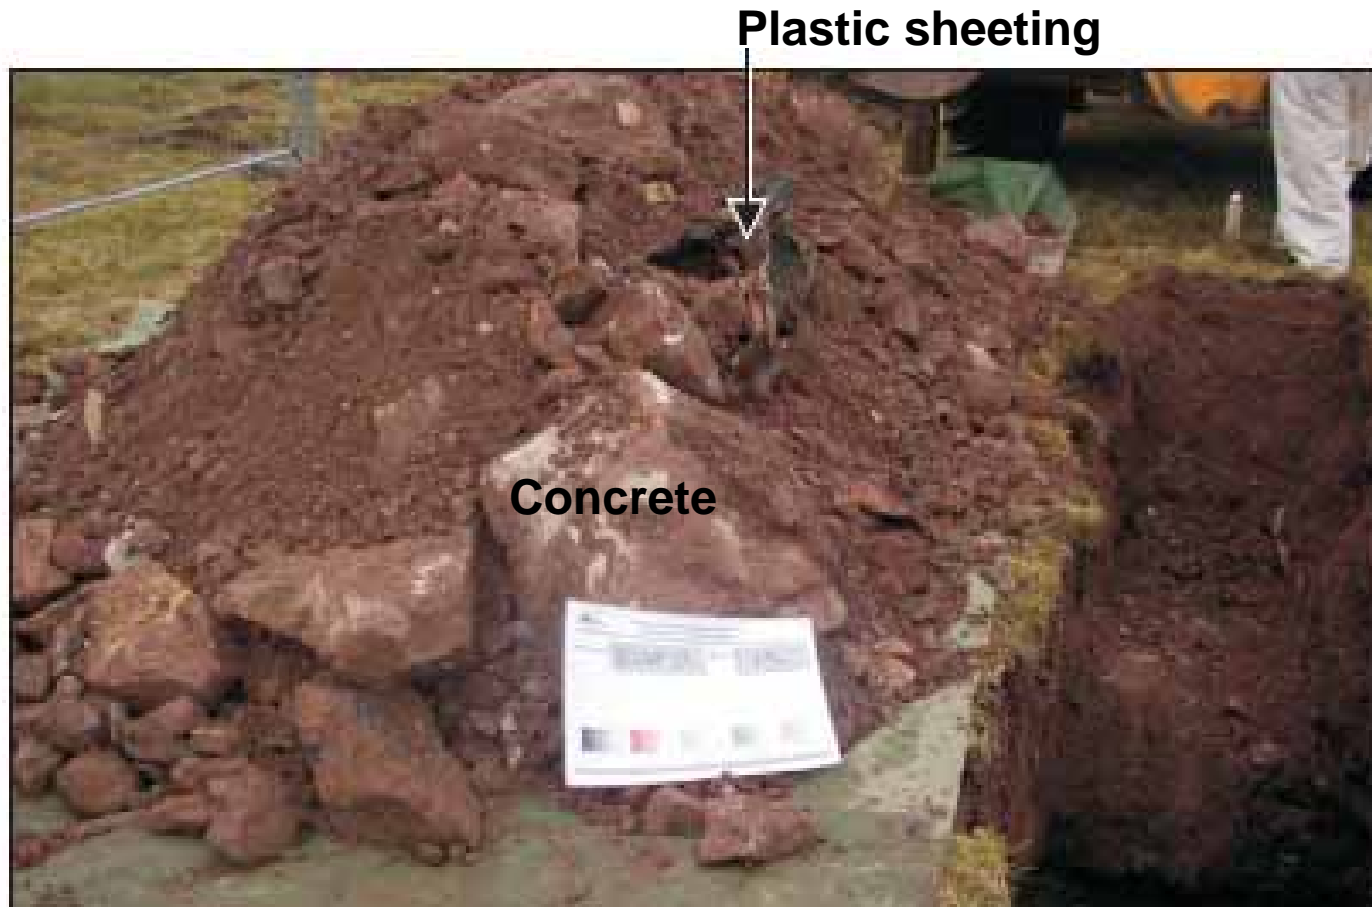
Typical waste (2005 trial pit investigation)

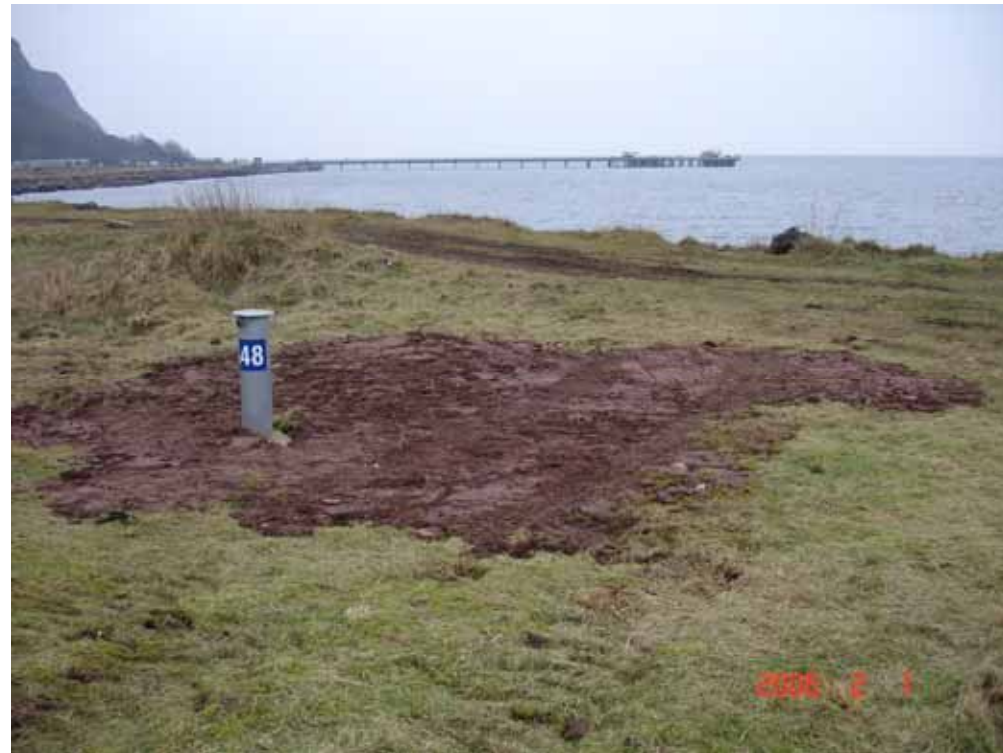
- Interim remediation of patch of surface contamination found by 2005 survey (Jan 2006)

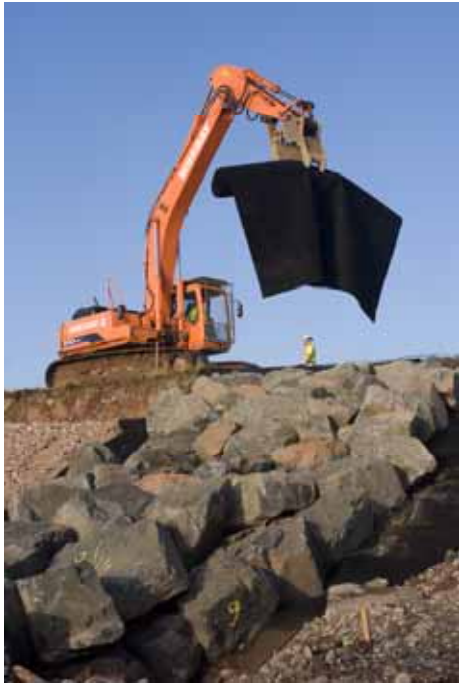
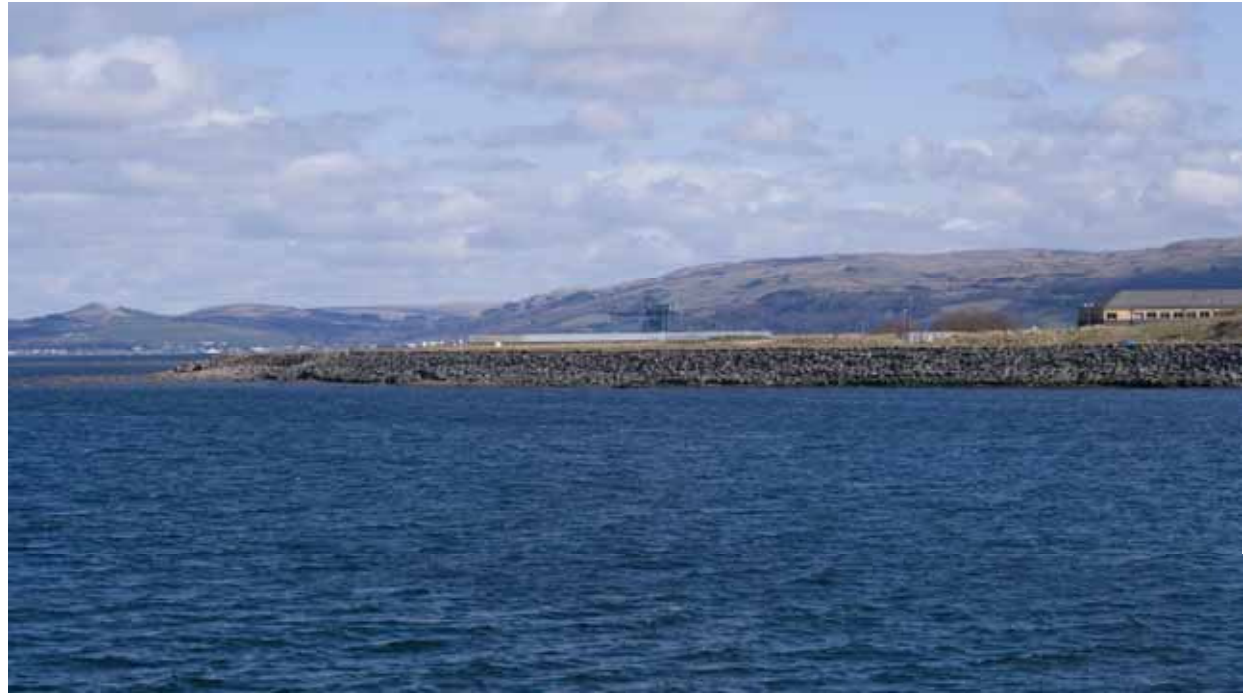
- Coastal defences damaged by severe storm, night of Hogmanay 2006
- Reinforcement work implemented 2007-08

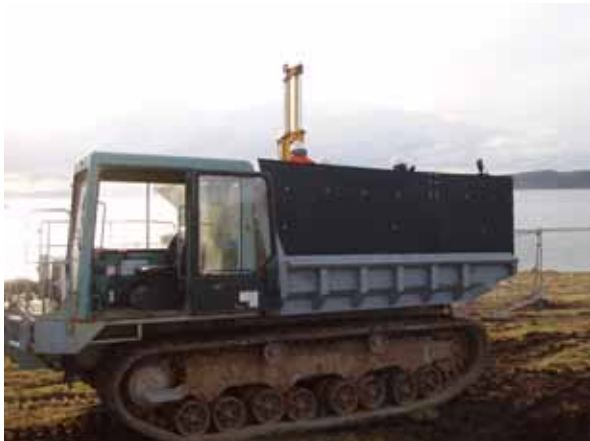
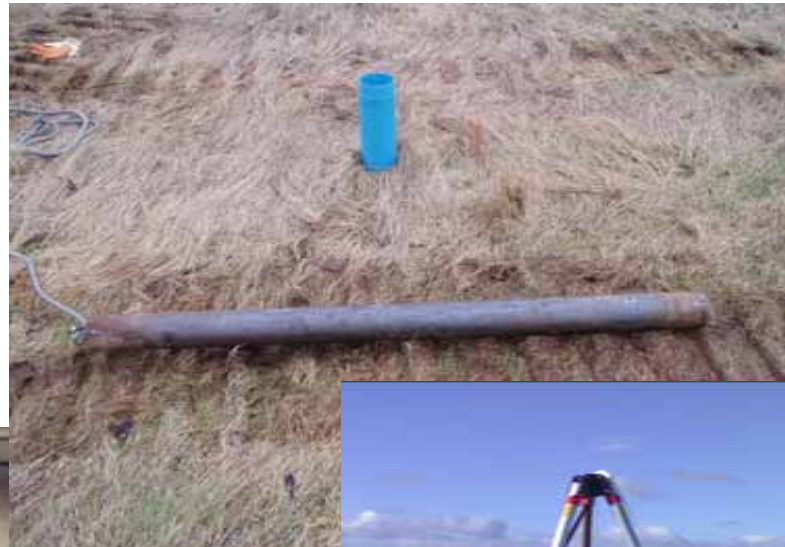
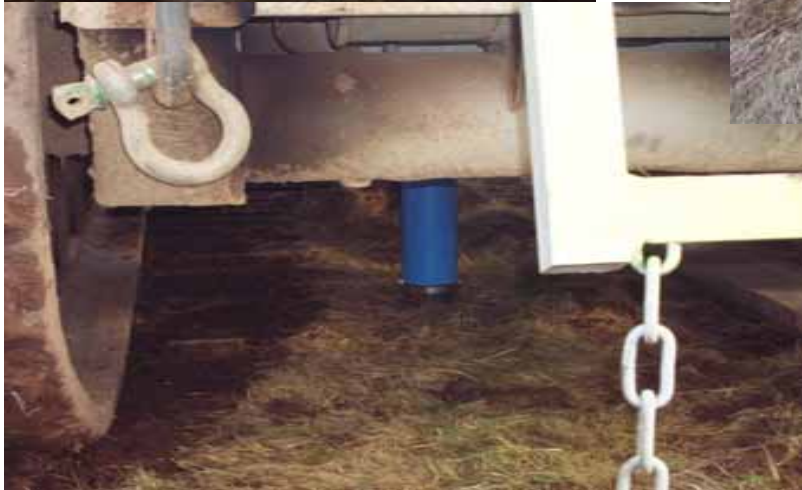
Direct push installation of temporary boreholes for down-hole gamma spectrometry

- Aerial photo-interpretation – Pit 1 capping mound within marker posts (but no features seen for other pits)
- Geophysics – inconclusive
- Trial pitting across inferred edges of pits – inconclusive
- Overall conclusion: radioactive contamination (caesium-137) probably the best guide to the location of the wastes
- Need for a large number of sub-surface contamination data points, but not ‘at any cost’
- Opportunity for innovative intrusive method, developed jointly with VT Nuclear Services and Golder Associates

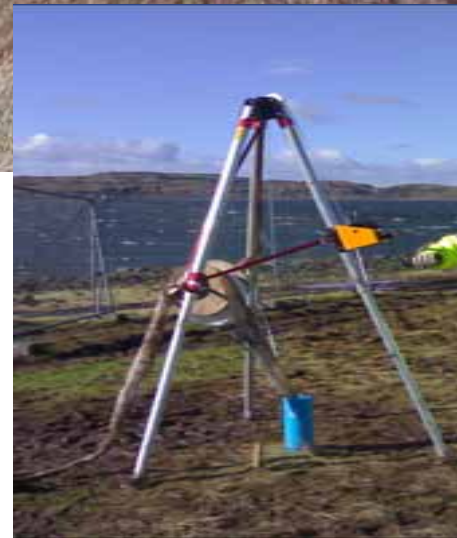
65
bore-
holes
